WADC-TR-72-314
FINAL REPORT
DECEMBER 1972

**RELIABILITY OF LINEAR INTEGRATED CIRCUITS
IN CERAMIC AND PLASTIC PACKAGES**

General Electric Company

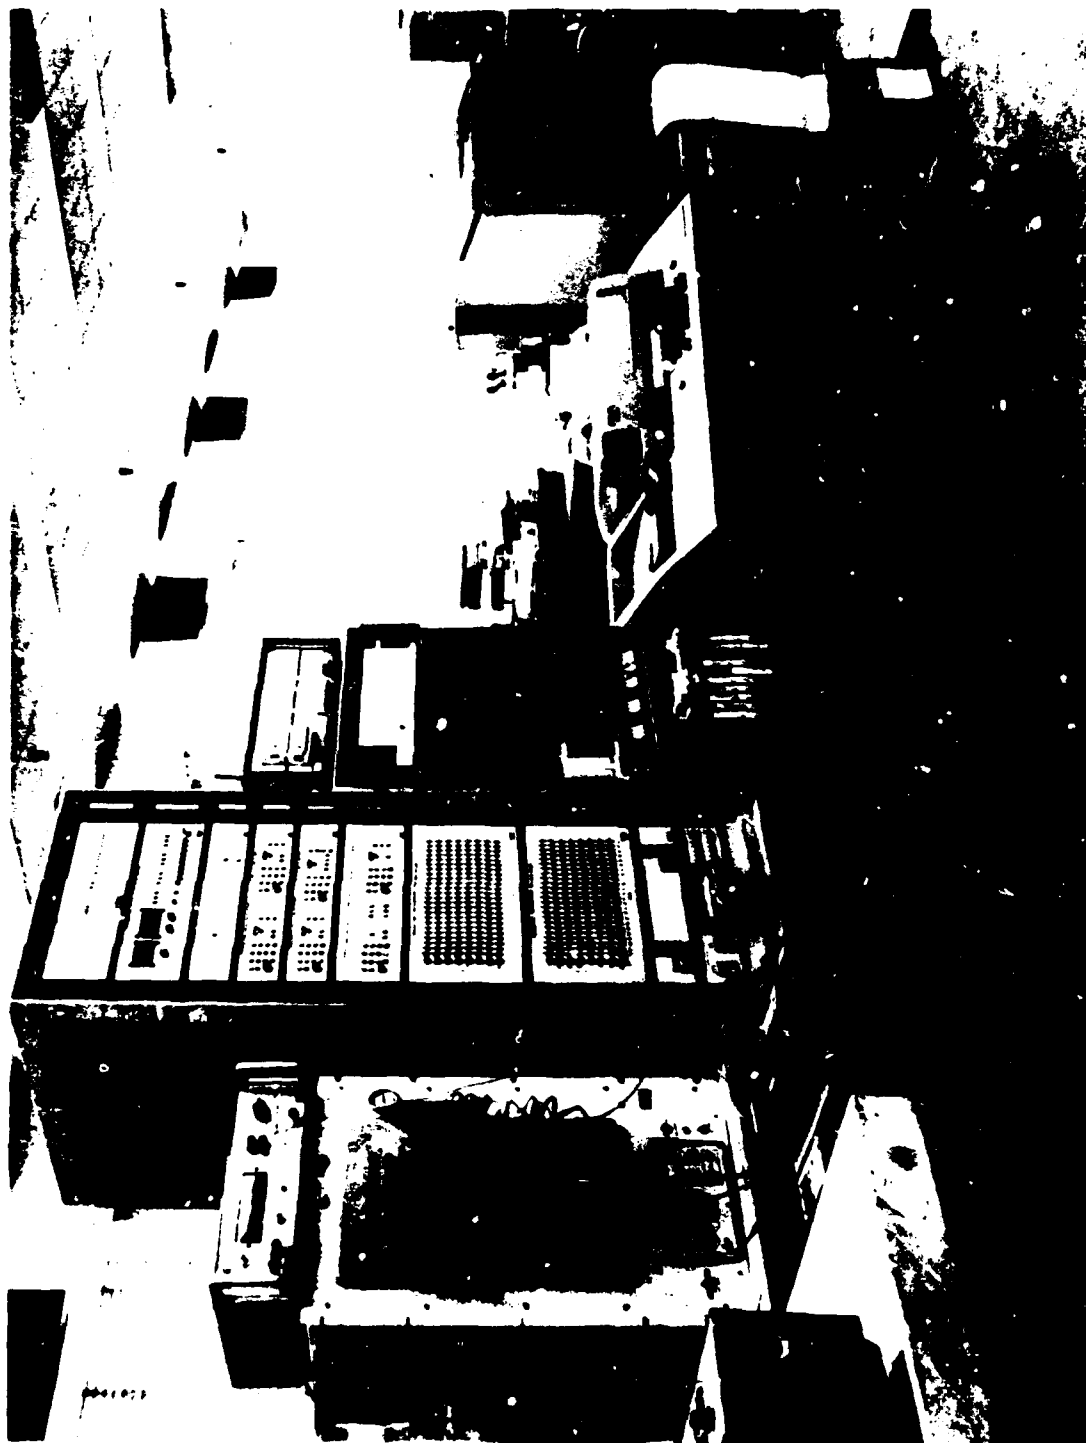
Figure 16a Monitored Temperature Cycle Equipment

A special set of test equipment was utilized in this program to perform the Monitored Temperature Cycle (MTC) Test. The equipment consisted of a programmable temperature chamber, a Teradyne J259 computer controlled test system, an electronic

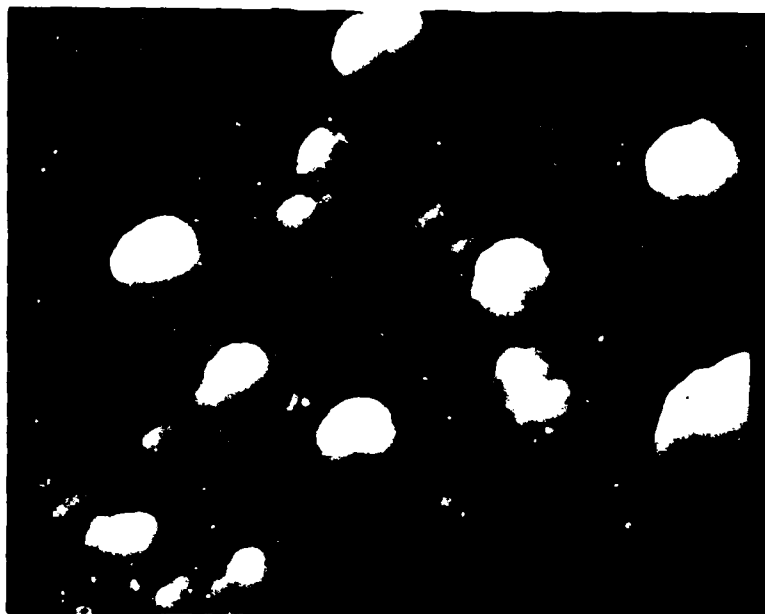
Figure 65 Device 4163 5000X
Same Crack As Figure 63

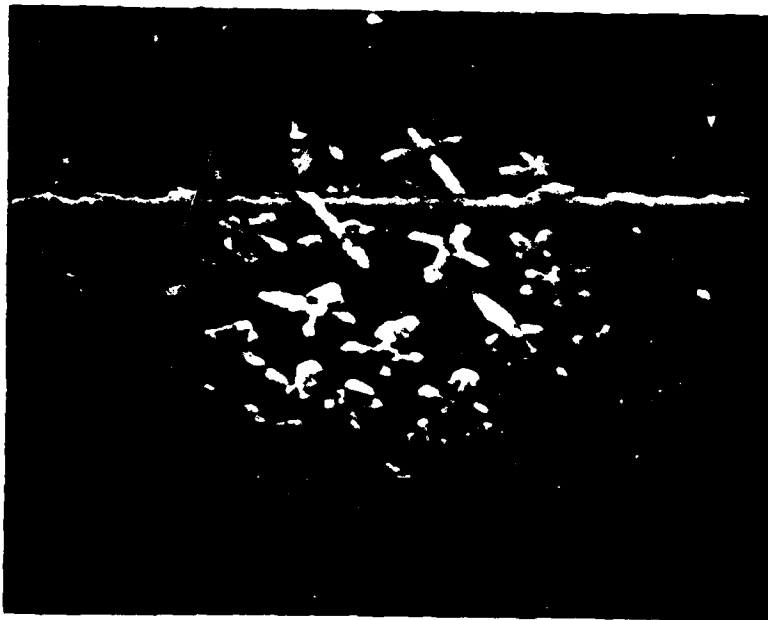
Figure 70 Device 5075 1000X
Corrosion Near Pin 5 - Same Contents as in Figure 69
This is a Specific Compound

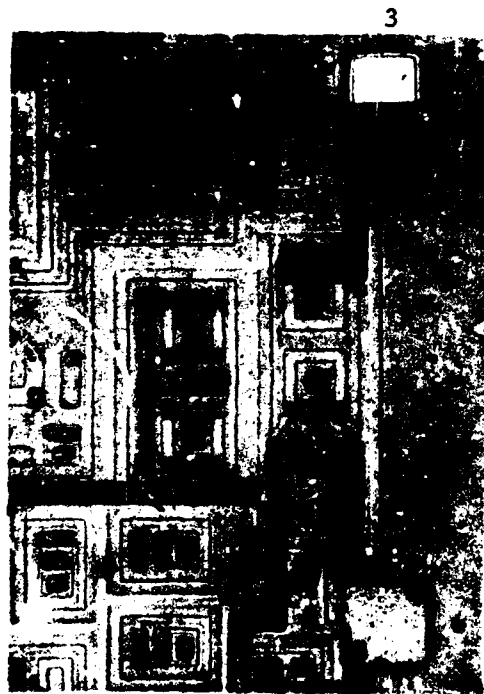
C-100X, Q₂

Gangbonds Etched off in Aqua Regia
Note Defects in Pad 3 in D
